## **Water safety and public liability**

### **Case study ~ Brereton Heath Local Nature Reserve, Cheshire**

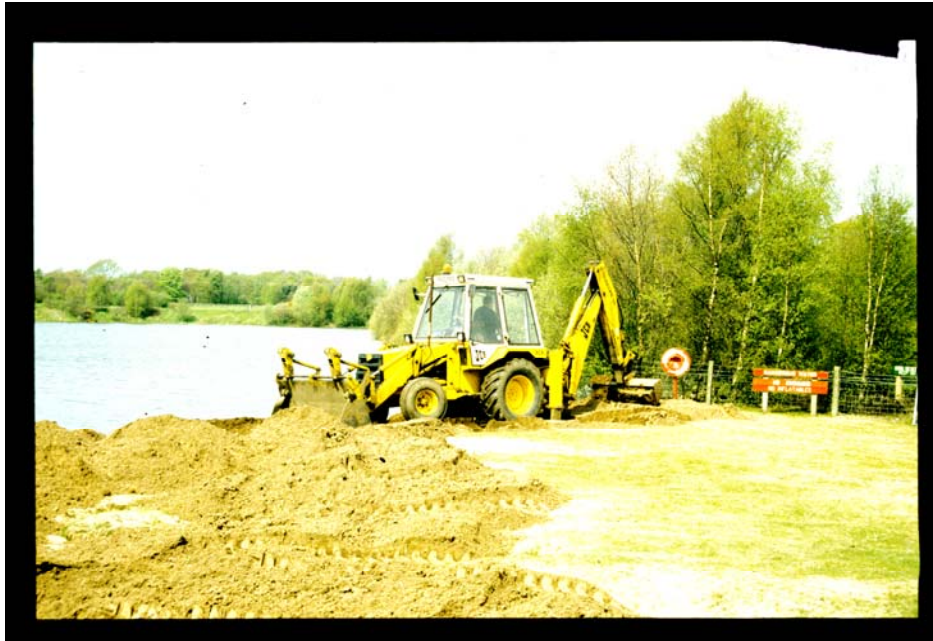
A decision was made to topsoil the sandy lake side areas. These areas were then fenced, and planted with an alder dominated mix of trees.

One of the main attractions for sunbathers and swimmers was the presence of three sand banks at the lake edge, which acted as 'beaches'. These areas have been fenced off, covered in top-soil, and planted with a mix of indigenous trees. Alder was found to be the most suitable species, due to its ease of establishment, and tolerance to drought. Two of these areas now form a bird reserve.

The first 'beach' was allowed to establish before work commenced on the second. This allowed vegetation to establish undisturbed by the public.

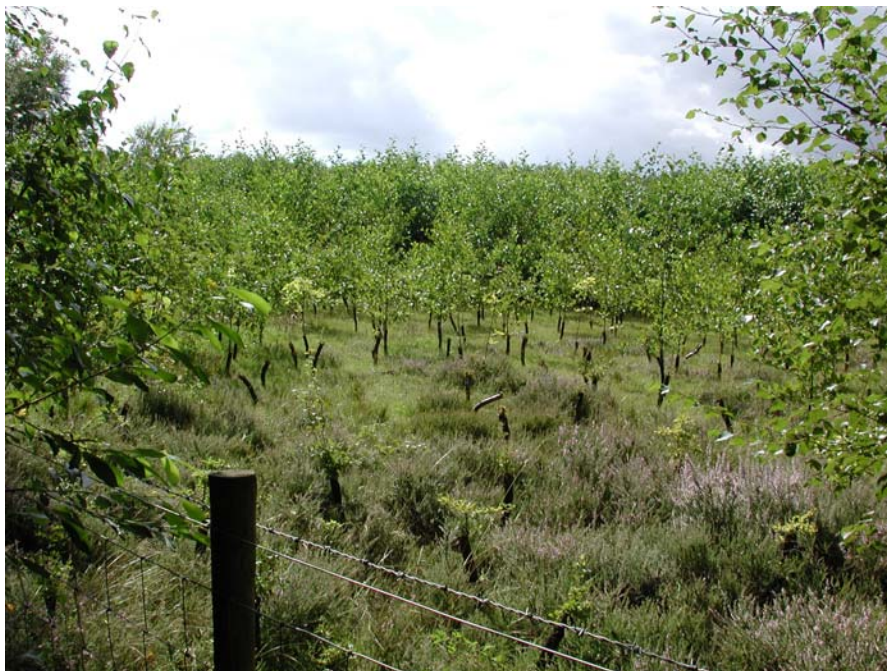
Within a few years, the character of the lakeside dramatically altered. Alder saplings proved resilient to dry periods, with rapid growth rates.

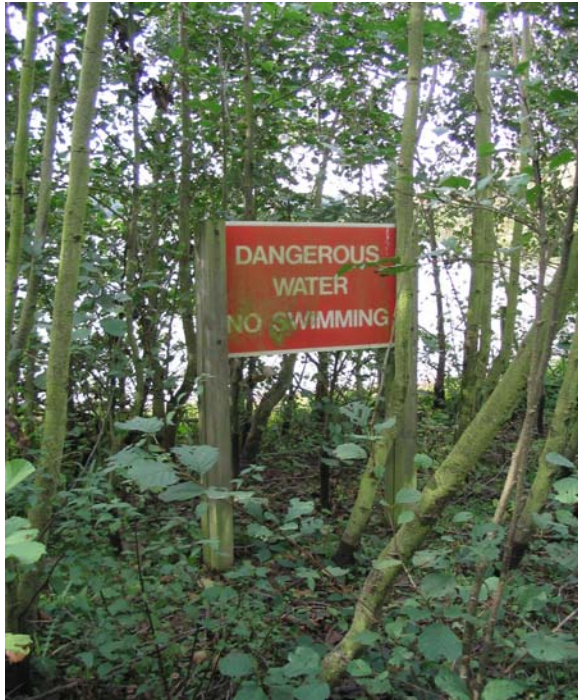
This warning sign, now surrounded by dense tree cover, was formerly surrounded by open sand.

Although Brereton Heath displayed 'Dangerous water; No swimming' signs at prominent positions from its opening, these were largely ignored. The high numbers using the water reinforced the swimming culture, beyond the control of staff. Visitors often believed that swimming must be legitimate, as so many people did it. Staff would even find young children left by their parents for the day, in order to go swimming, or to play with inflatable boats.

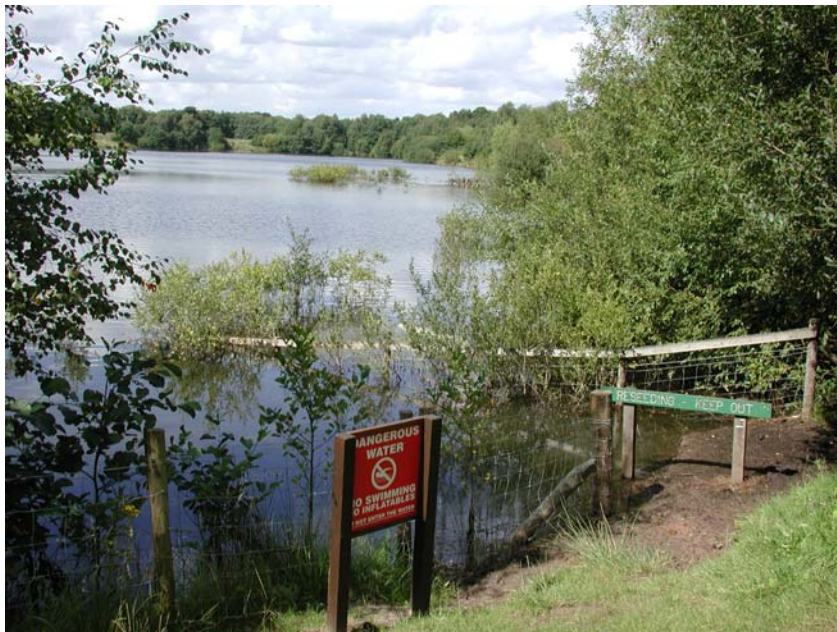
The eastern end of the lake in 2008, with the so-called 'beach' areas now transformed into a bird reserve.
